Metering

Identifying Corrosion

A Quick Reference Guide for Meter Readers.

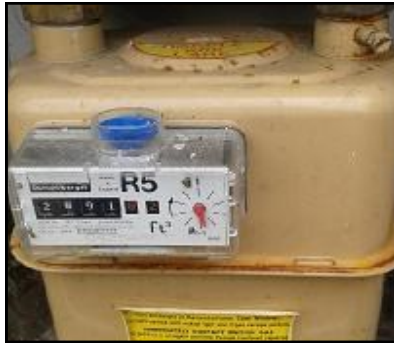
Only limited and superficial corrosion is evident.

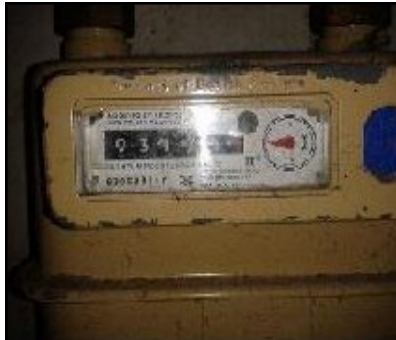
Paint/coating mostly intact. Some areas of light surface corrosion, but generally sound.

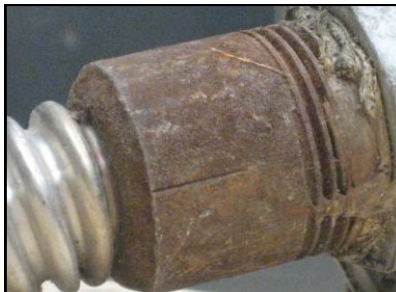
Evidence of surface rust only; normally indicated by light brown deposits with no apparent 'eating' away of the metal.

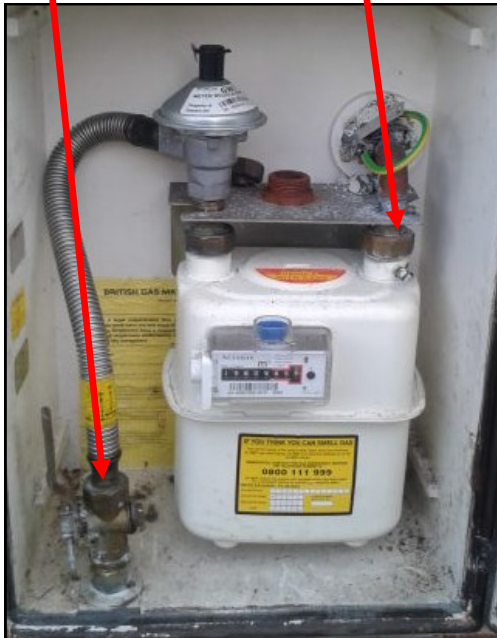
The majority of meter installations extend from the outlet of the Emergency Control Valve to the meter outlet connection fitting.

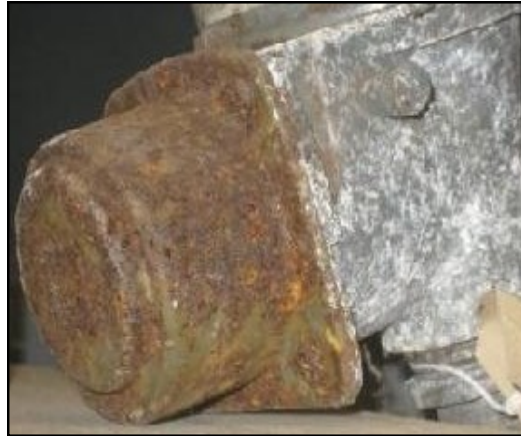
High level of corrosion evident on a specific component of the meter installation.

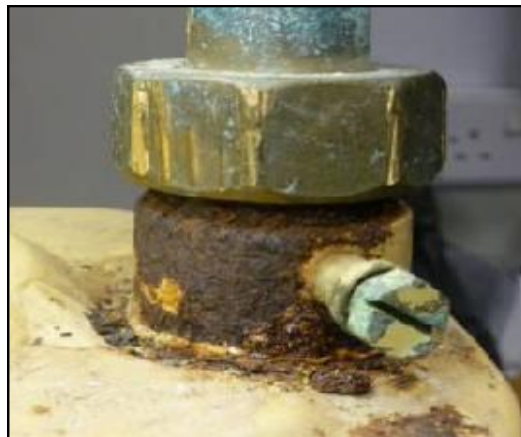
High level of corrosion evident on a small localised area on the meter installation.

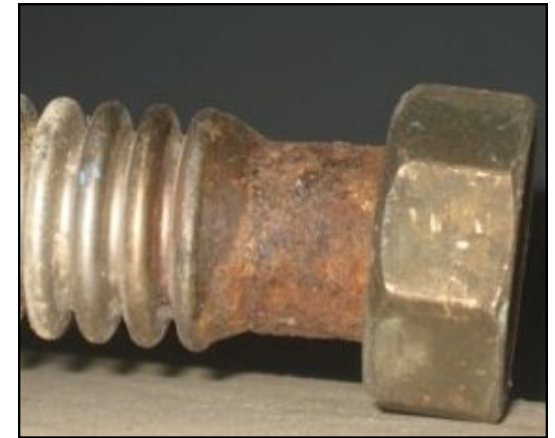
Metal has multiple signs of being 'eaten' away or is perforated.

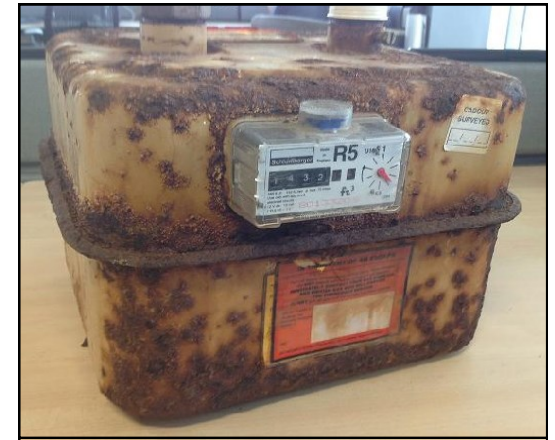
Rust flaking off and paint coating absent over a large surface area.
